Subject: **Engineering Geology Report**
Proposed Shopping Center
3759-3763 State Street
Santa Barbara, California
Arroyo Geotechnical Project No. 15555-2000

Reference: **Report of Geotechnical Investigation and Seismic Hazard Evaluation Study**
Proposed Shopping Center, 3759-3763 State Street, Santa Barbara, California
Report Dated May 6, 2005, Arroyo Geotechnical Project No.: 12184-2000

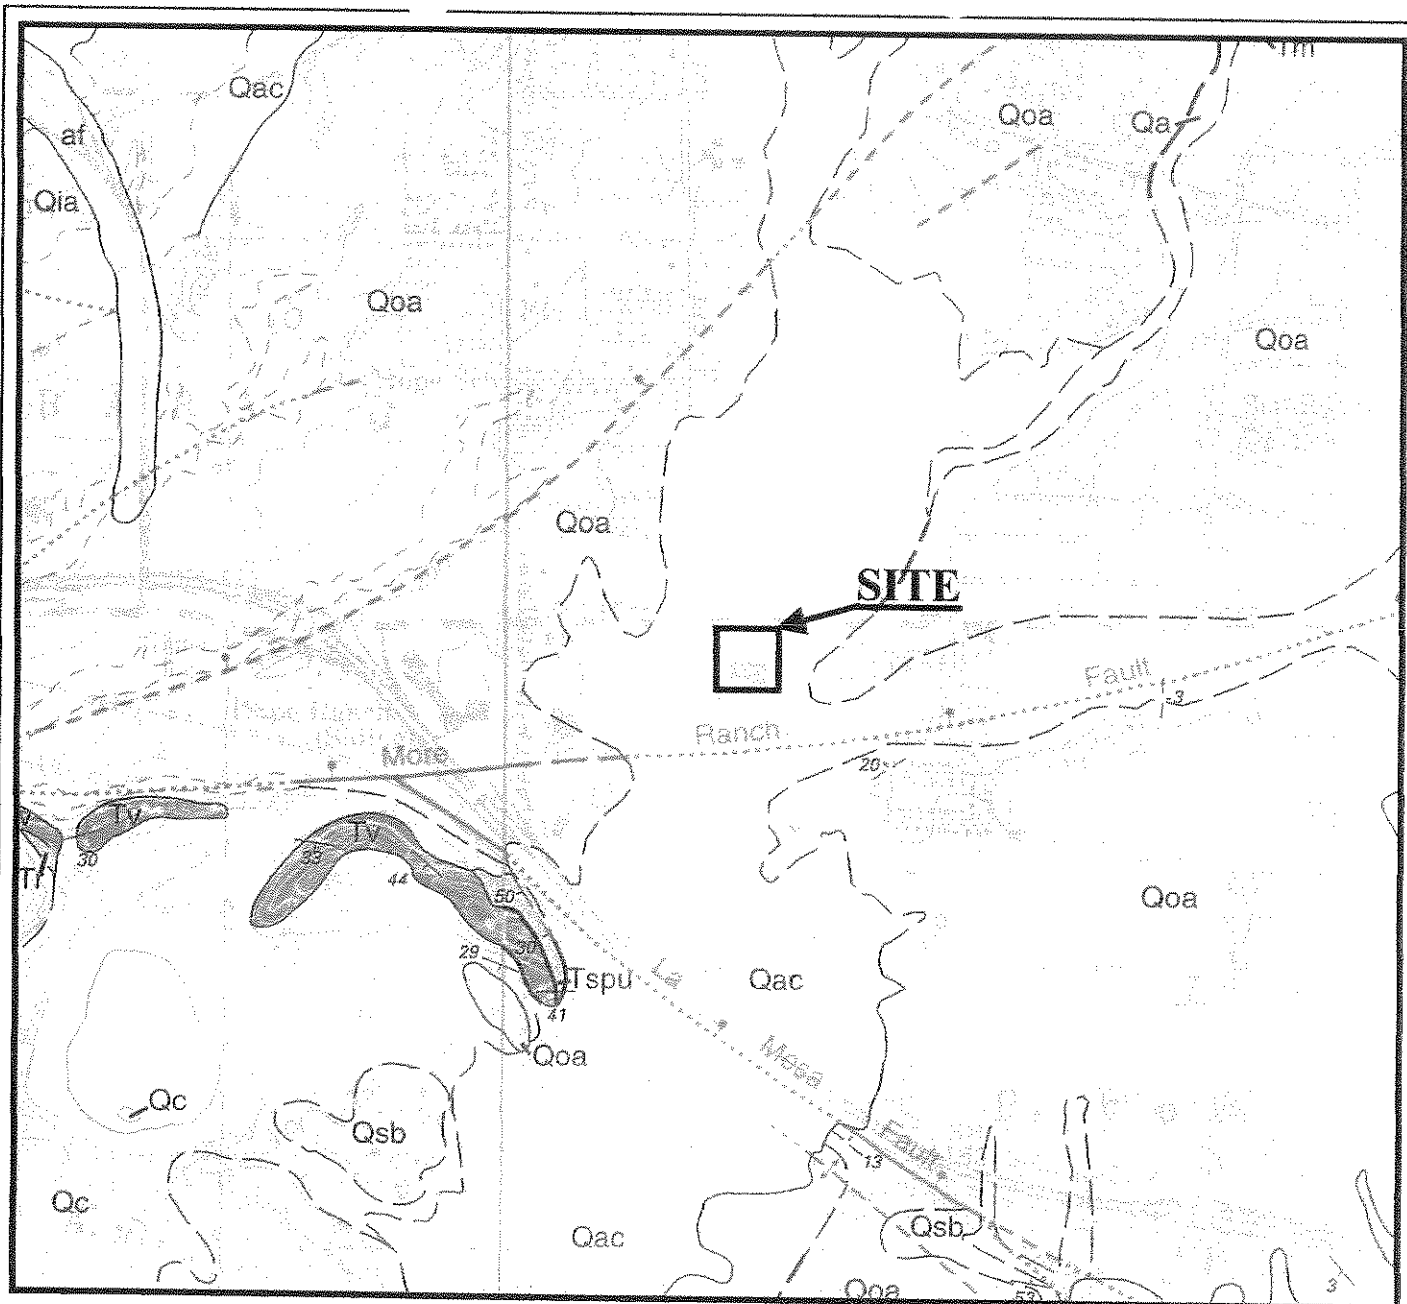
FIGURE
1

Qac	Alluvium and colluvium (Holocene and upper Pleistocene)
Qc	Colluvium (Holocene and upper Pleistocene)
Qoa	Older alluvial deposits (upper and middle Pleistocene)
Qsb	Santa Barbara Formation (middle Pleistocene)

REGIONAL GEOLOGIC MAP
3759 - 3763 State Street, Santa Barbara, California

Figure 1 Regional Geologic Map
Figure 2 Regional Fault Map

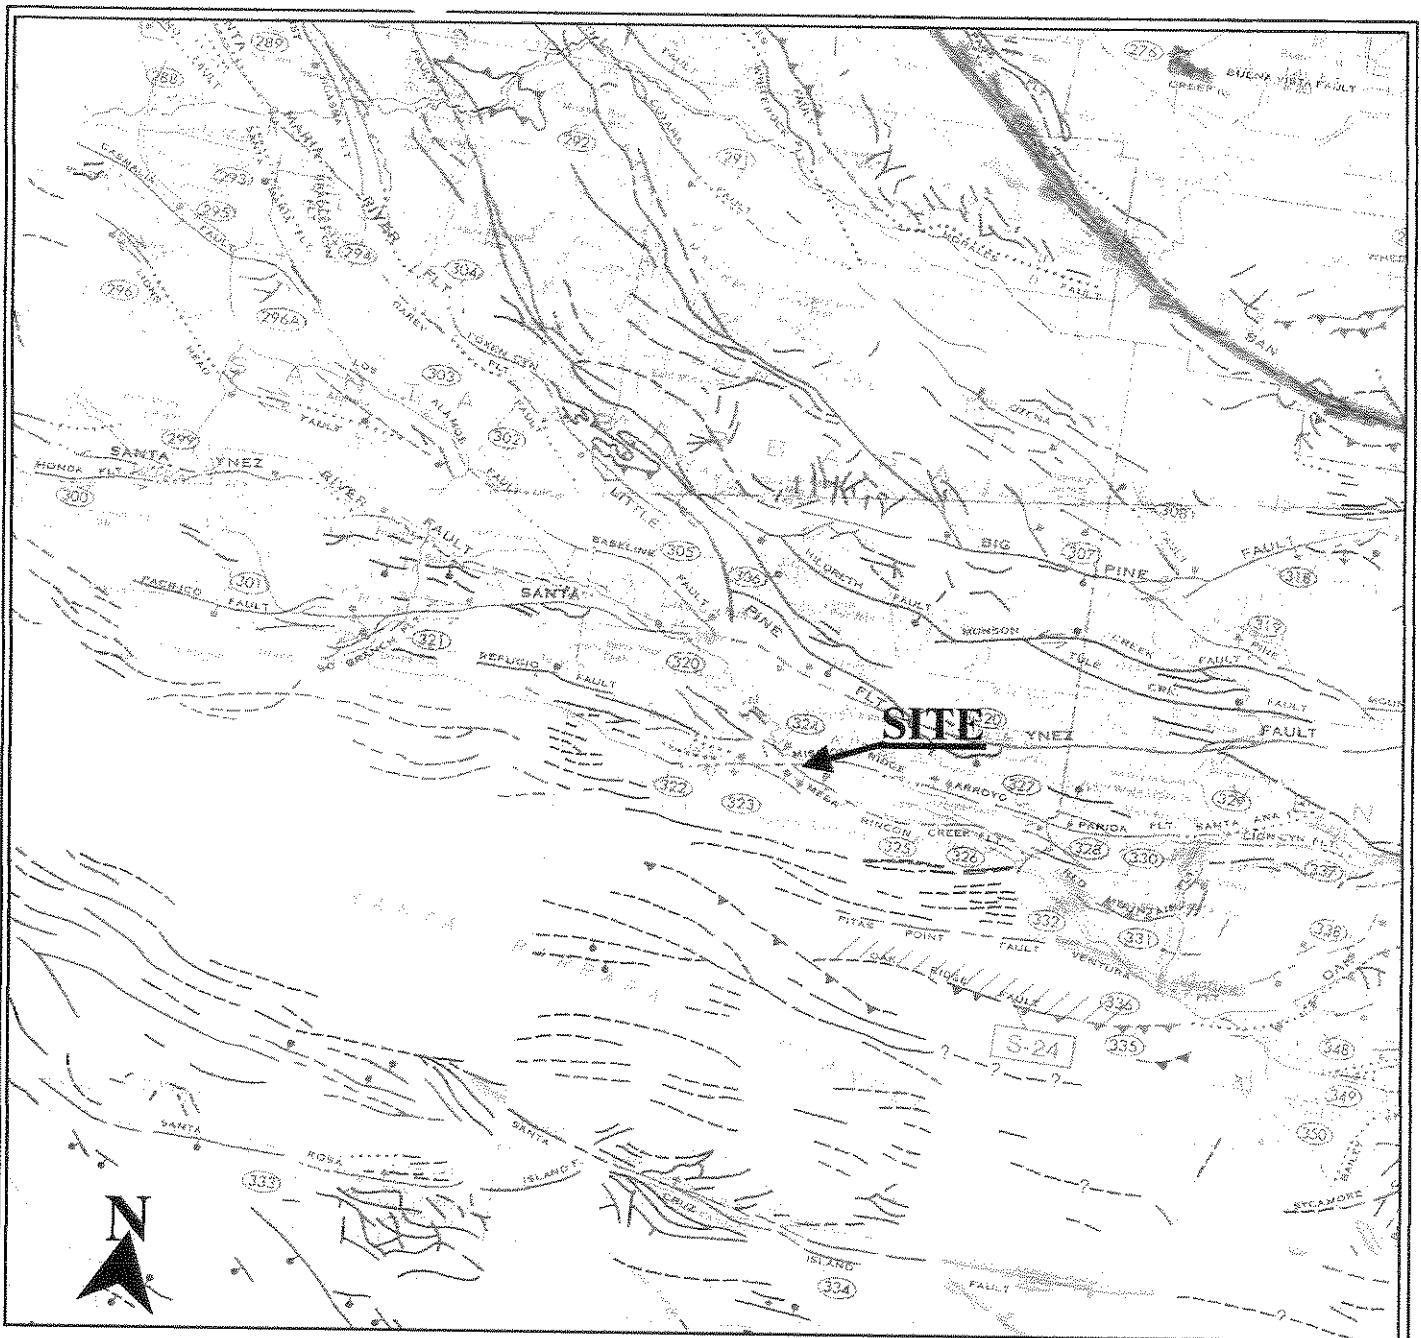
- Fault along which historic (last 200 years) displacement has occurred.
 - Holocene fault displacement (during past 10,000 years).
 - Late Quaternary fault displacement (during past 700,000 years).
 - Quaternary fault (age undifferentiated).
 - Late Cenozoic faults within the Sierra Nevada.
 - Pre-Quaternary fault (older than 1.6 million years) or fault without recognized Quaternary displacement.
- Pink band added to emphasize location of historic fault displacement.
